AOB: Preliminary information based on the NIB CH interim report

## Gotthard freight train derailment accident

10.08.2023 (approx. 12:50)

Ad-hoc NSA Network meeting 27.09.2023

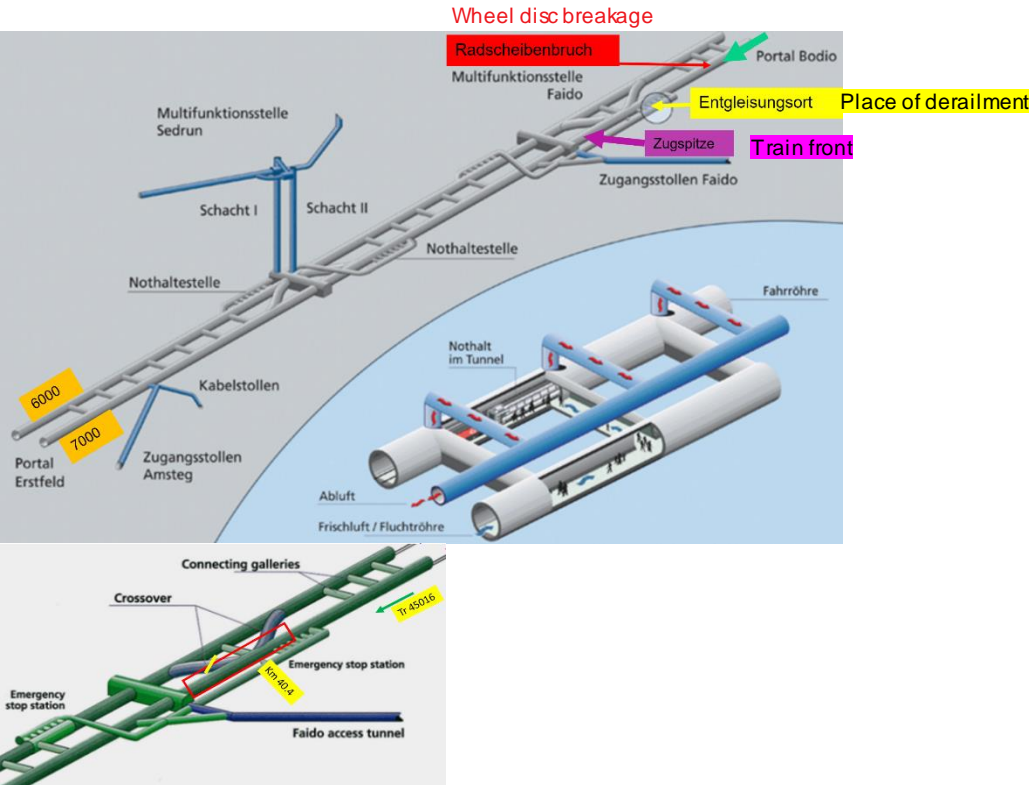
- Freight train nr. 45016 operating under SBB lead was on its way from Chiasso to Basel with 2 locomotives (BR 185) and 30 freight wagons of different types

- Approx. 10km after entering the Southern portal of the 57km Gotthard Basis Tunnel, a fragment of the wheel disc of the first wheelset of the 11<sup>th</sup> wagon broke away in the direction of travel, followed shortly after by other wheel fragments → *damage to the infrastructure (bi-block concrete sleepers)*

- The wheelset continued to hang diagonally to the wagon → *the train ran further 4km without major material infrastructure damage*
- Approx. 17km after the tunnel portal another piece of wheel broke away and the diagonally derailed wheelset below the wagon (still attached) hit the sleepers and destroyed all switch drives before the Faido track change point

- Sixteen wagons derailed and partially overturned. The train got separated between wagons 13 and 14. Some wagons got onto the diverting track

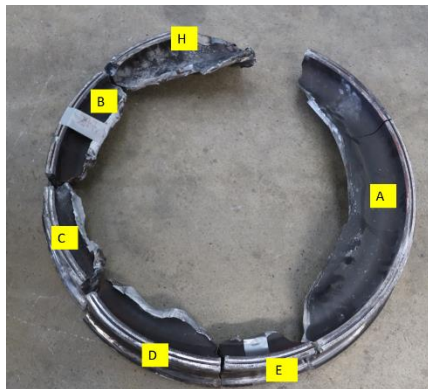
Riss im Radsteg  
BA314 / ZDB29 (mit  
Schräge unter dem Spurkranz)

Similarities identified with the "JNS broken wheels" types BA004 and BA314/ZDB29

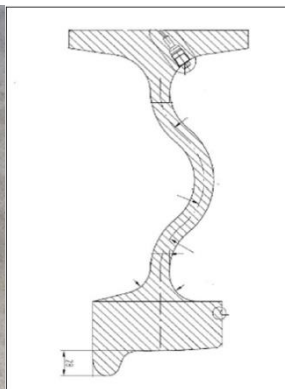
Riss im Radkranz  
BA 004

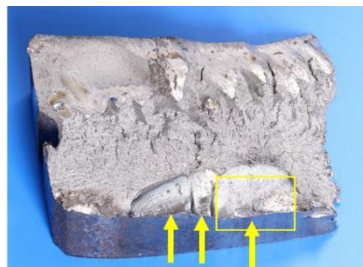
## Broken wheel: Type BA 390

Breakage on the running surface of the wheel through microscopic examination

- The wheel breakage occurred due to fatigue (vibration cracks) starting from cracks on the running surface of the wheel.
- The cracks developed into the wheel until a violent fracture
- Multiple cracks-more or less perpendicular to the surface- grew in parallel.
- The crack growth occurred over an extended period of time. The running surface indicates numerous further cracks

- Wheelsets and wheel discs are safety critical components which in event of default can lead to serious accidents
- Regardless of the cause of the wheel disc crack, once initiated, the crack grows slowly in the wheel continuously until the wheel is forced to break
- During technical train inspections in operation a crack can only be detected to a limited extent, depending on its extent and on the visible wheel area
- At this moment of the Interim NIB report publication, there are no indications of pre-existing operational deficiencies that could have led to the derailment

- Immediate measures by the wagon keeper TWA: all concerned type of wheelsets (*approx. 150*) were withdrawn from operation
- 19.09.23: The preliminary results of the metallurgical examination were presented to all stakeholders

- FOT (NSA CH) is making stakeholders aware at national level of the publication of the NIB interim report and will inform them that the safety measures according to the conclusions of the JNS “broken wheels” should be extended to wheel-type BA 390

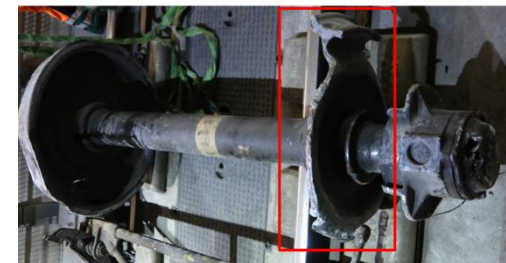
Missing wheel pieces on wheelset 1 (right side)

Wheelset 1 run in total 140.000 km since 2017 (since last level 2 maintenance)  
The wheel (with wheelset load 22.5 t.) was manufactured in 2018

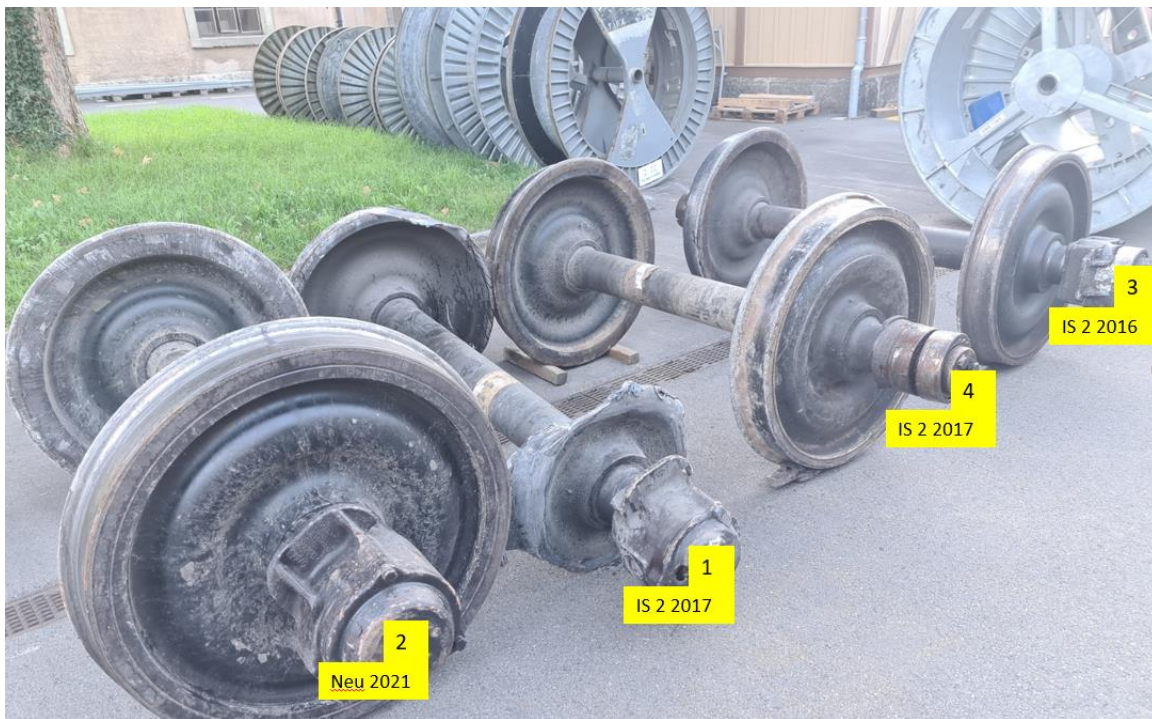
The 4 wheelsets of wagon 11 (466-2)\*

The other 3 wheelsets (2-4) were also analysed

- The ultrasonic testing found no volume defect in the wheel rims of wheelsets 2-4
- Linear indications (25-35mm length) were found in the axial direction around the entire circumference of wheelsets 2 and 3
- Isolated linear indications (approx. 15mm length) were found in the axial direction on the running surface of wheelset 4

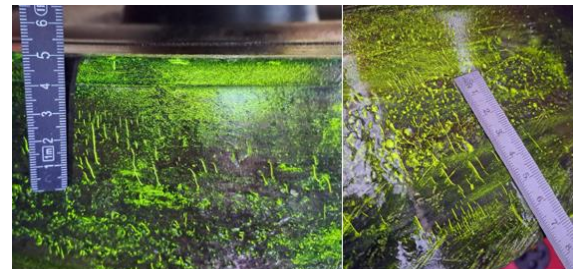
Ultrasound magnetic particle testing of wheelsets 3-4
